February blog post - Matt Gregory

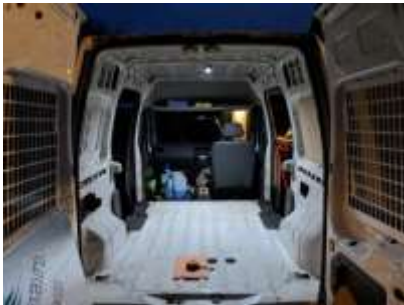
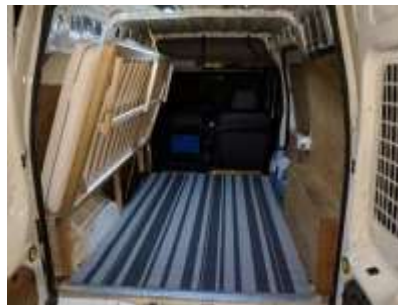
Completely stripped out and making some patterns out of cardboard to fit insulation RHS. I marked out some 'stations' on the floor and took some measurements off those to help with planning the layout.

After two days work: Liquid petroleum gas removed, engine serviced, half of cage removed, some insulation finished, folding bed built. The rug just happened to fit perfectly and was only £12 Bonza!

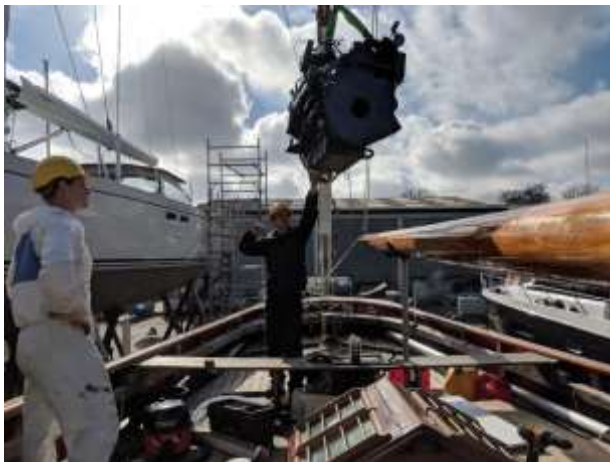
On my first day working in the yard, I removed an edging plank on the coach roof to try and find the source of a leak that was rotting its way into the aft cabin. The coach roof was added when the boat was in Palma some 30 years ago and apparently has always been a bit pants.

I started by digging out the plugs after finding they were too shallow to be pulled out by driving a self-tapping screw into them. Next, removing the bronze screws, most of which the heads snapped off or had to be drilled out. Some had to be cut through with the oscillator as we wedged the plank out, which turned out to have been stepped into the members behind it. The rot was mostly in the coaming and the beam, and seemed to stop after a couple of inches. I cut a hole for a graving piece into the coaming and most of the beam rot could be dug out using your finger until you found some good wood underneath, which we then treated with wood sealer as a temporary fix.

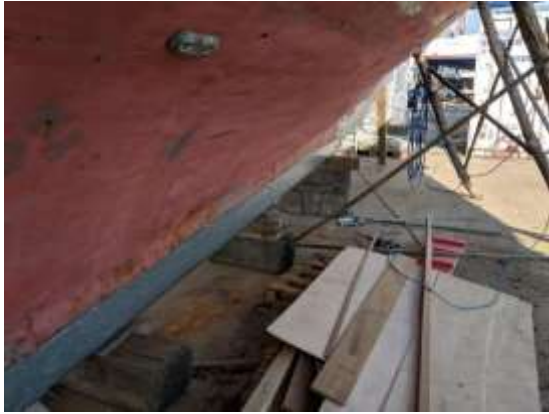
Next, I tried for half a day to remove a seized anchor chain roller on the stem head. The thing was precision engineered to 1/1000th of an inch and must have got some grit or some salt build-up in it as it was solid as a rock. I even tried turning the sheave over with some synthetic line and the windlass, but I don't think there was enough leverage.

Defeated, I gave it a good soaking with some WD40 and left it to think about how stubborn it was being and to reconsider its life choices, while I raked out some problem hull seams and chalked and red leaded them back up. A good tip Adam gave me was to burn off the wispy bits of oakum with a butane torch before leading. But it did feel a bit nerve-wracking holding a naked flame to a 106-year-old wooden boat.
